**DEPARTMENT OF TRANSPORTATION****DIVISION OF ENGINEERING SERVICES**

Contract #: 04-0120F4Cty: SF/ALA Rte: 80 PM: 13.2/13.9File #: 1.28**WELDING INSPECTION REPORT****Resident Engineer:** Casey, William**Address:** 333 Burma Road**City:** Oakland, CA 94607**Report No:** WIR-027591**Date Inspected:** 11-May-2012**Project Name:** SAS Superstructure**OSM Arrival Time:** 700**Prime Contractor:** American Bridge/Fluor Enterprises, a JV**OSM Departure Time:** 1730**Contractor:** American Bridge/Fluor Enterprises, a JV**Location:** Job Site**CWI Name:** As noted below**CWI Present:** Yes No**Inspected CWI report:** Yes No N/A**Rod Oven in Use:** Yes No N/A**Electrode to specification:** Yes No N/A**Weld Procedures Followed:** Yes No N/A**Qualified Welders:** Yes No N/A**Verified Joint Fit-up:** Yes No N/A**Approved Drawings:** Yes No N/A**Approved WPS:** Yes No N/A**Delayed / Cancelled:** Yes No N/A**Bridge No:** 34-0006**Component:** SAS OBG**Summary of Items Observed:**

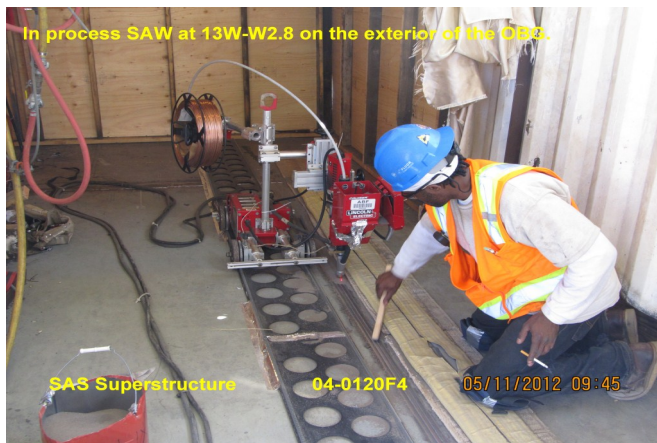
### 13W-W2.8 (Exterior)

This QA Inspector randomly observed QC Inspector William Sherwood verify the pre-heat temperature of the CJP joint at y+ 100mm to y+12500mm of 13W-W2.8 prior to the Submerged Arc welding (SAW) process performed by ABF welder Kenneth Chappell (ID 3833) utilizing a Lincoln track mounted wire feeder. This QA Inspector verified that the remote oven for the ESAB EN 760 Flux was in the on position with the dial set at 250° F. ABF welding Superintendent Dan Ieraci provided a remote temperature gauge to verify the flux temperature inside of the oven. This QA Inspector verified that the F7A2-EM12KH8 electrode spool was compliant with ABF-WPS-D1.5-4042B-Revision 1. QC Inspector William Sherwood measured the parameters for amperage, volts, travel speed and the heat input as the welder adjusted the controls on the Lincoln track mounted wire feeder. This QA Inspector made subsequent observations to monitor quality and noted that the work at this location was completed on this date and appeared to be in general conformance with the contract documents.
